UNDERGROUND STORAGE TANK ASSESSMENT (UST) REPORT FOR BUILDING 191 CNC  
CHARLESTON SC  
11/08/1996  
NAVFAC SOUTHERN

South Carolina Department of Health and Environmental Control (S.C.D.H.E.C.)  
Underground Storage Tank (UST) Assessment Report

Facility Name: Charleston Naval Base Complex, Bldg 191

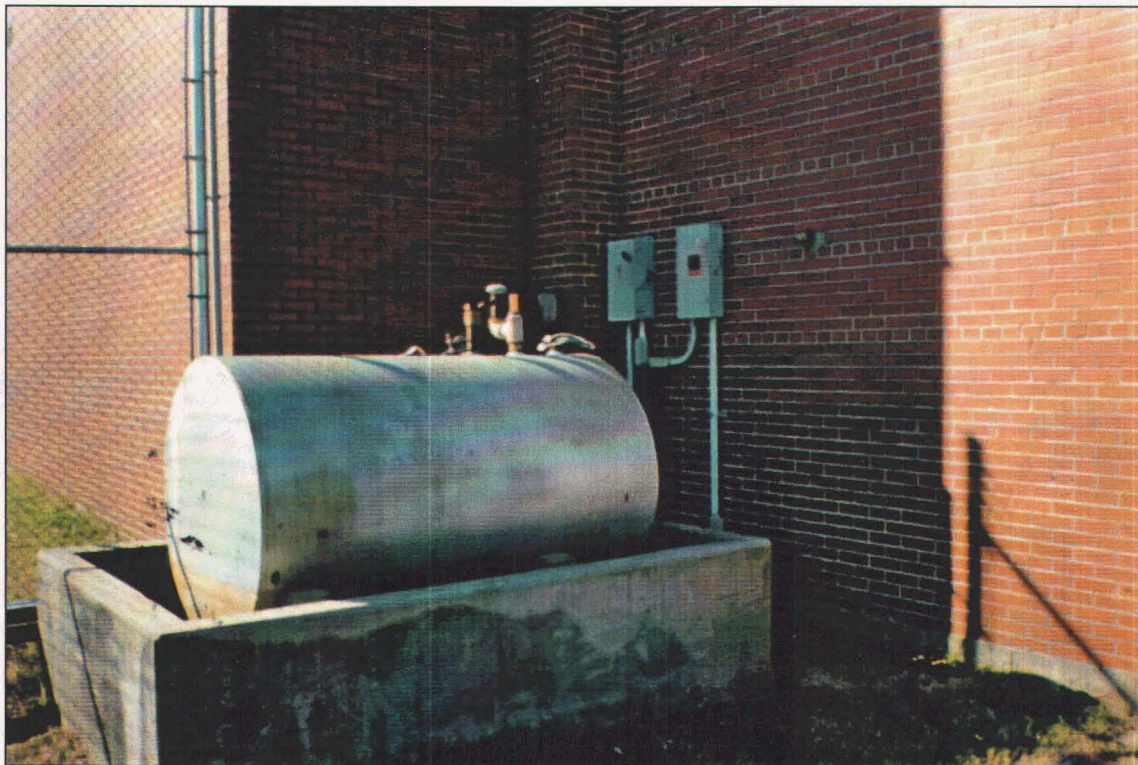
AST 191 was in good condition and contained no corrosion, pitting, or holes. UST 191NW had a protective coating of black pitch. It was also in good condition and contained no corrosion, pitting, or holes.

Photo 1: AST 191 in the concrete berm prior to removal.

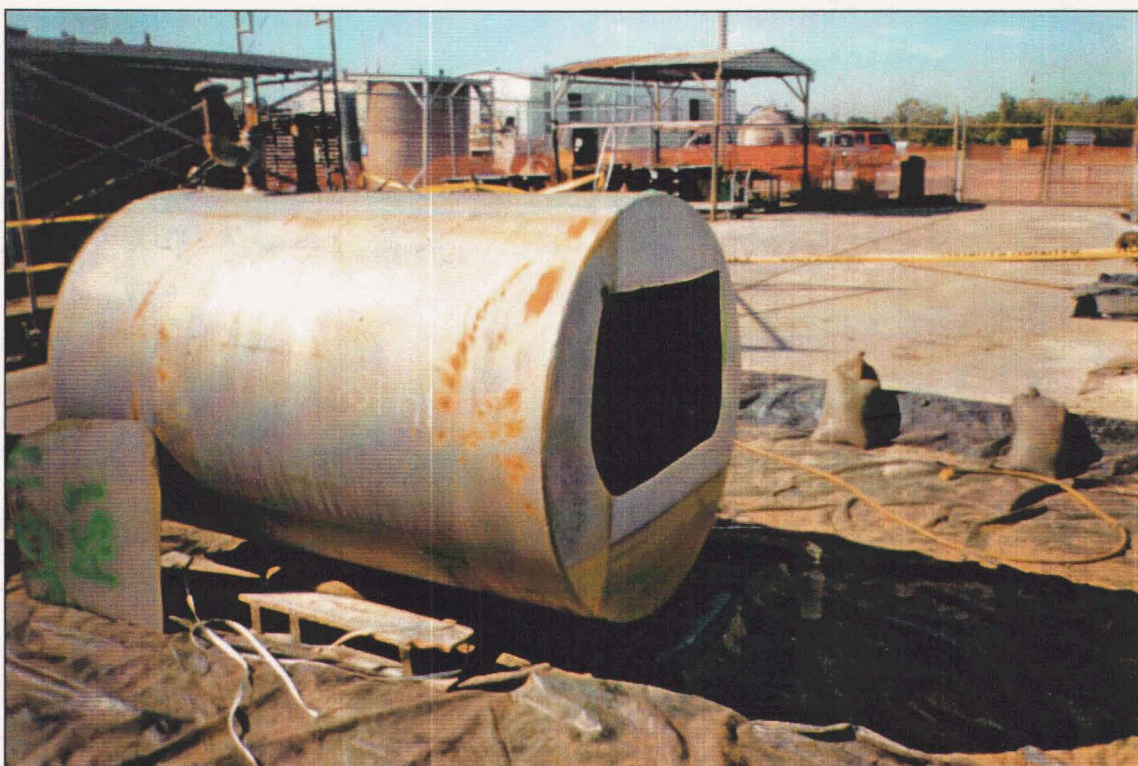
AST 191 and UST 191NW were removed, drained, cut open at both ends, and cleaned with a steam cleaner. They were then cut up for recycling as scrap metal. (See Attachment III.)

Photo 2: AST 191 during cutting and cleaning.

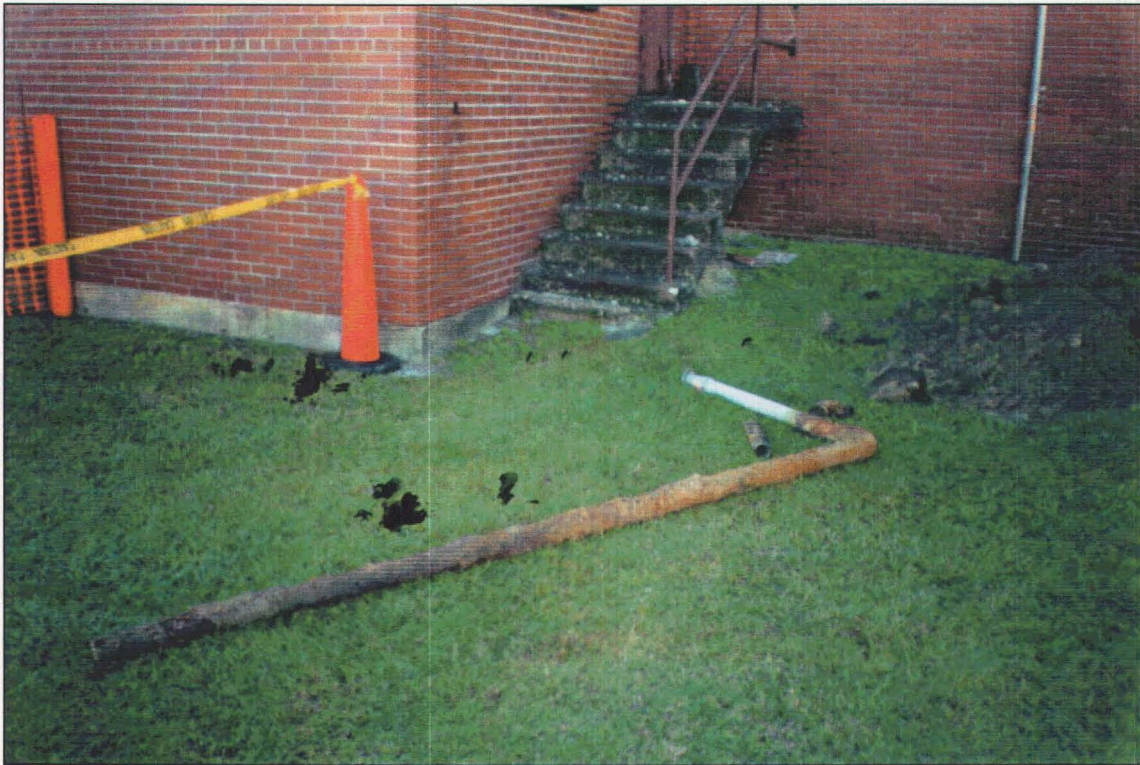
UST 191NW's steel vent and fill lines contained mild corrosion and pitting throughout their length, but no holes were found. The tank's copper supply and return lines were also in good condition; however, evidence indicates that these may not have been the original lines. A loose connection was found where the copper return line attached to the tank. The loose connection or possible replaced supply and return lines provide the best explanation for any impacted soil found at the east end of the tank excavation.

Photo 3: UST 191NW fill pipe after removal.

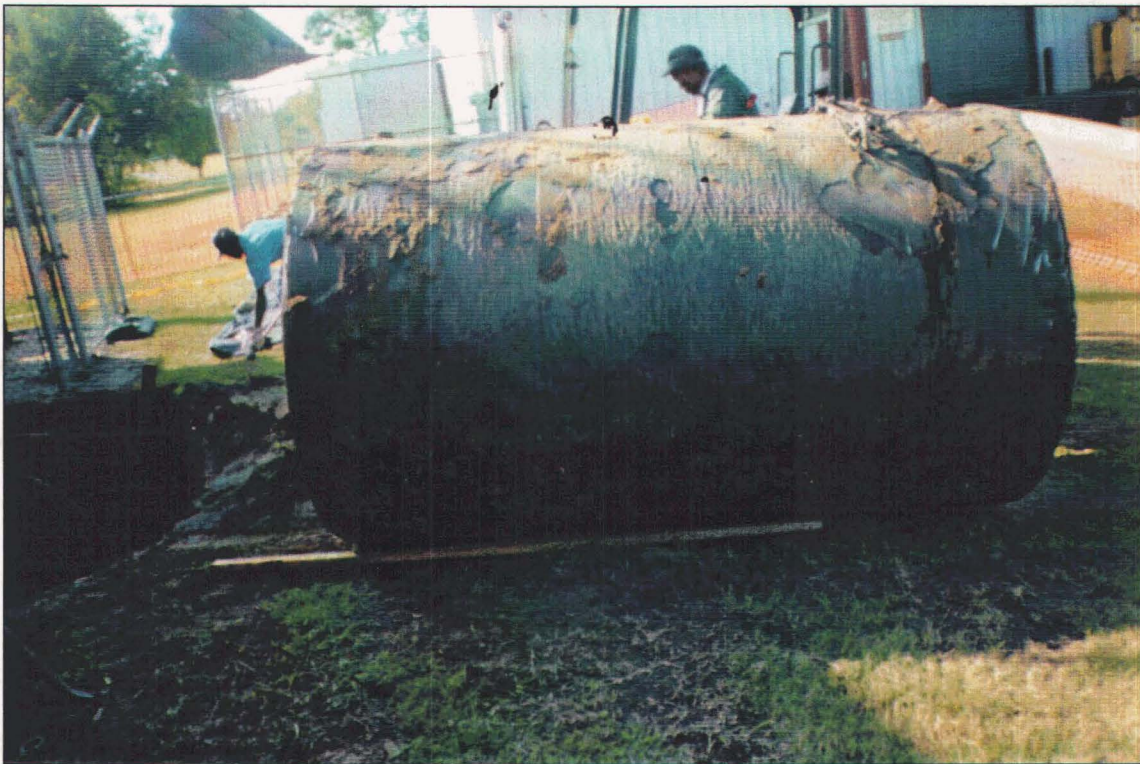
Photo 4: UST 191NW after removal from the excavation.
